Sequential Disaster Forensics: An Application to Floods in the City of Grimma

UFZ Discussion Papers

November 2018

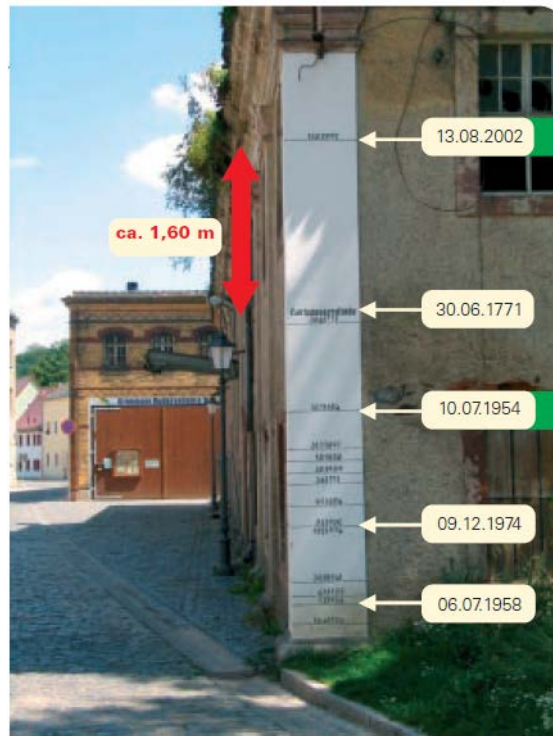
Figure 14 Water level of historic floods, on the Großmühle building in Grimma centre (Landestalsperrenverwaltung des Freistaates Sachsen, 2006).

Historical records show that heavy floods occurred in Grimma in the years 1573 and 1771, while minor floods were expected every 20 years (Siedschlag, 2010). The last major flood before 2002 happened in Grimma in 1954, but the water level was not comparable either to the 2002 nor the 2013 floods (Figure 14 and Figure 15).

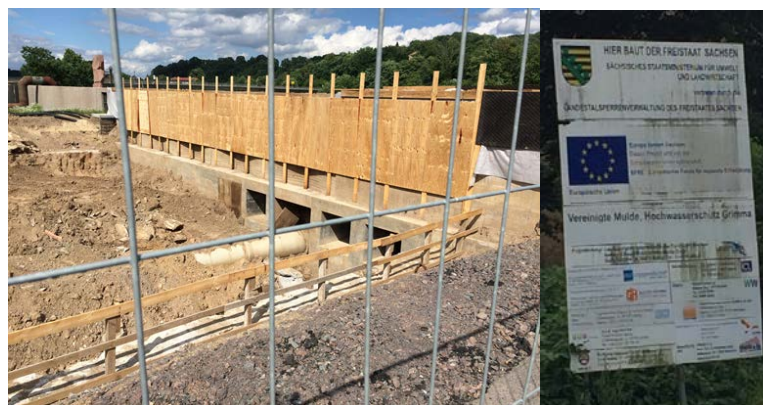
Figure 31 Floodwall, project 4, under construction (June 2017)

Project 4 begins at the Pöppelmann Bridge and leads to the end of the natural rock massif north of Grimma. A freestanding reinforced concrete wall is envisaged; on the north side of the Pöppelmannbrücke, the protection system runs inland to the foot of the bridge and then swings to the North to meet the new Mulde bridge in a line that is curved towards the river. The height of the flood protection system varies between 2,5 m and 3 m (*hochwasserschutz-grimma.de*, 2017). This project is still under construction (as to June 2017) and is expected to be finished by 2018 (LVZ, 2016) (Figure 31).

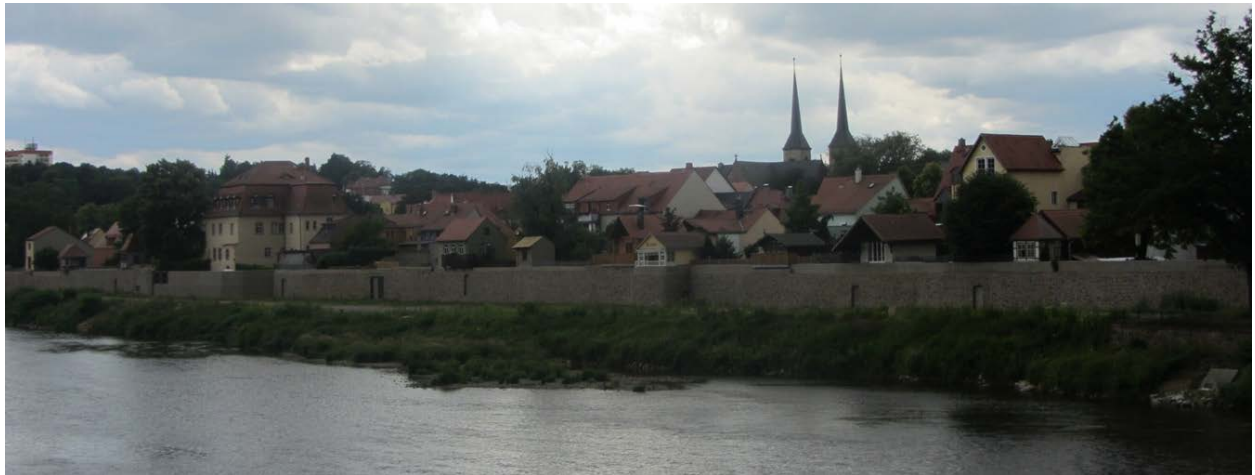
Figure 33 New floodwall, photo taken across the Mulde River by the authors (June 2017)

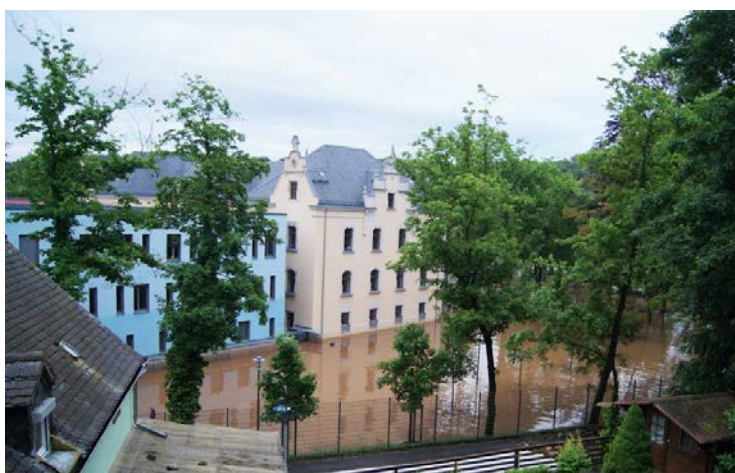
Figure 34 *New police station flooded during the 2013 flood
(Colditzger-tageblatt online newspaper, 2013)*

The 2013 flood caused damages of around 150 million euros in Grimma, with about 650 buildings damaged (Grimma Municipality, 2017). These included two schools, one music school, a kindergarten, the city hall, the district court and the new police station (Figure 34).

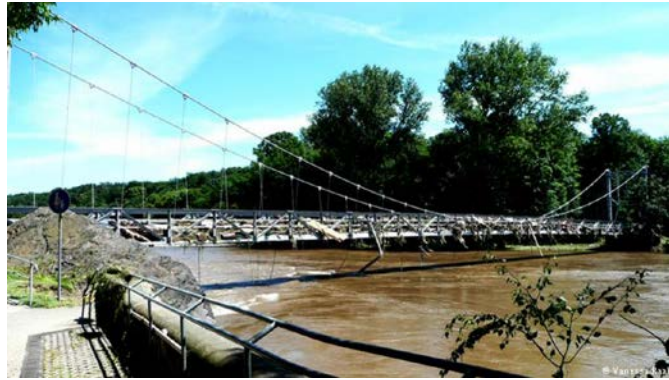
Figure 35 *Suspension bridge covered in debris on June 6th 2013 (DW, 2013)*

The suspension bridge over the Mulde river was covered with flotsam and unpassable, though it was not damaged (Figure 35).
